Engineering Geological Assessment of Selected Landslide Dams Formed from the 1929 Murchison and 1968 Inangahua Earthquakes

A thesis
submitted in partial fulfilment
of the requirements for the degree
of
Master of Science in Engineering Geology
at the
University of Canterbury
by
Timothy Richard Nash

UNIVERSITY OF CANTERBURY

2003

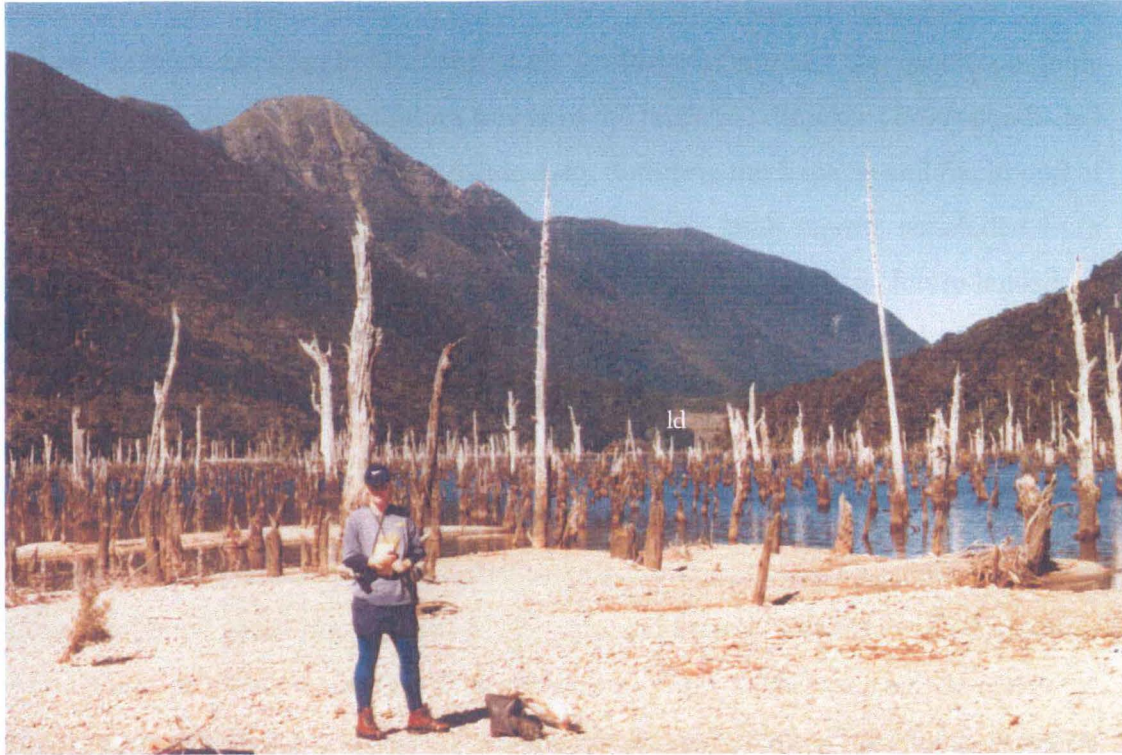
Fig 4.2. View of Lake Stanley looking northeast at location 2 (engineering geological map) with the landslide dam (ld) material in the background. The average lake elevation is 770 m.a.s.l. The brown staining on the tree stumps indicates a lake level higher than present caused by either seasonal variation (location 1 Map 1) (Photo source: D Nottage; photo taken 13.3.1997, person unknown).

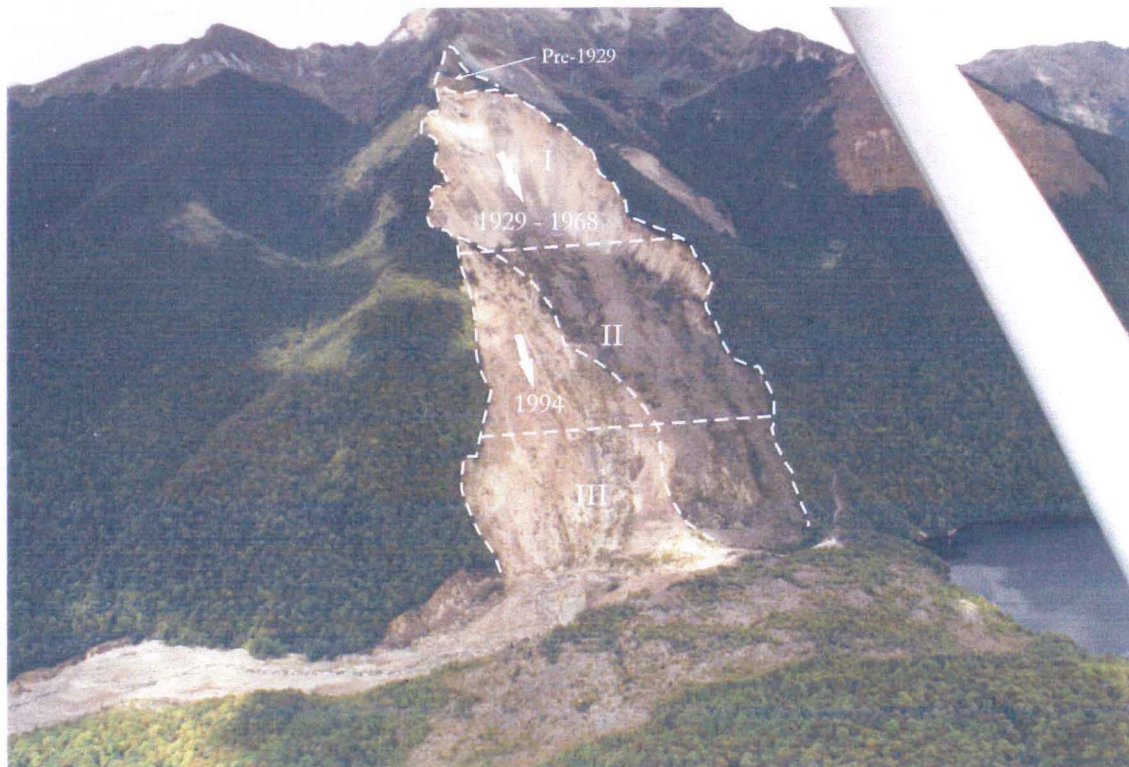
Fig 4.3. Aerial oblique photograph of Lake Stanley dam-forming landslide looking southwest. The landslide is divided into three zones displaying contrasting lithological composition and temporal activation. Zone I is the main source of landslide debris for the pre-1929 landslide, 1929 landslide, and landsliding between 1929 and 1968. The most recent landslide was from Zone II in 1994 and is clearly distinguished in the photo. River drains from right to left (photo taken by T. Nash December 2002).

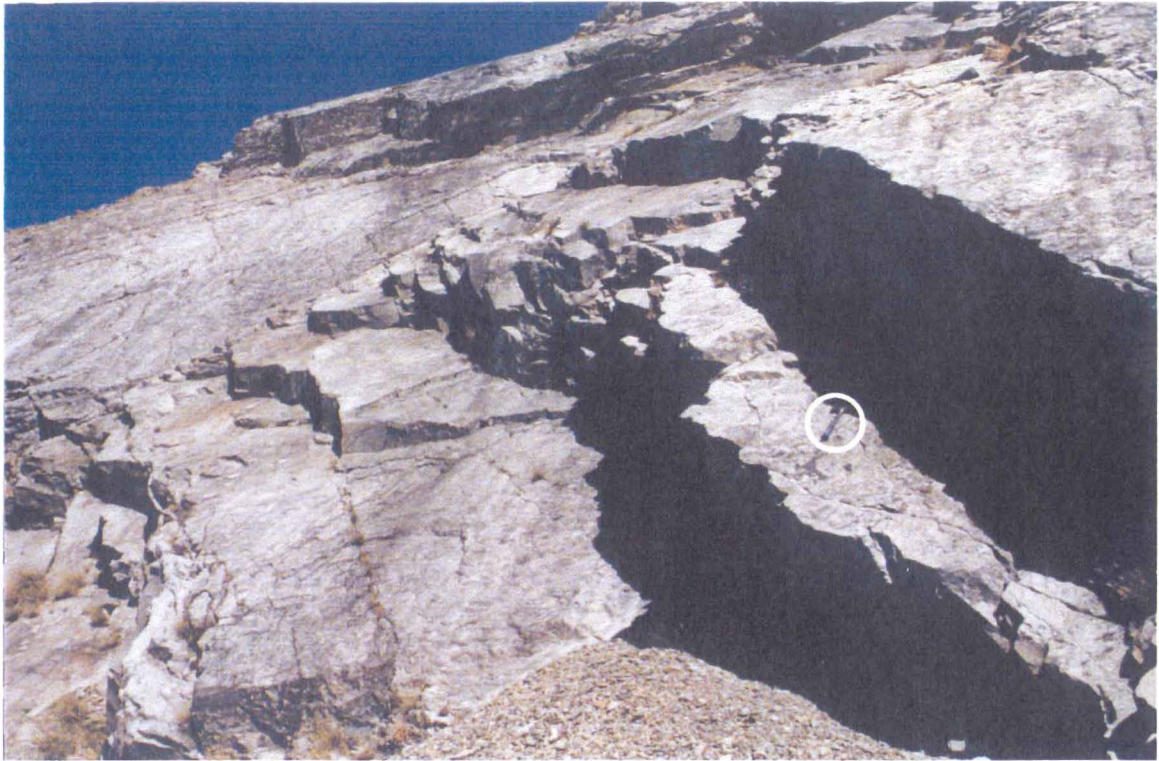
Fig 4.4. Major joint sets dipping to the northwest at $\sim 45\text{-}50^\circ$ from the eastern lateral margin rock mass Zone I. Joints are smooth, clean and planar. Bedding at this location is sub vertical trending from left to right of the photo in volcaniclastic sedimentary rocks. Photo looking southeast at location 2 Map 1. Rock hammer circled for scale (Photo taken February 2003).

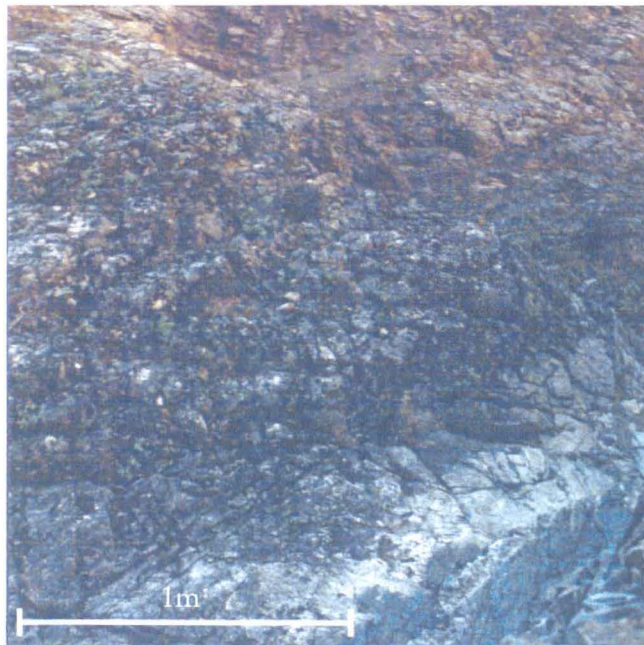
Fig 4.5. Closely jointed volcaniclastic sedimentary rock mass exposed in the upper western lateral margin of Zone I (location 3 Map 1).

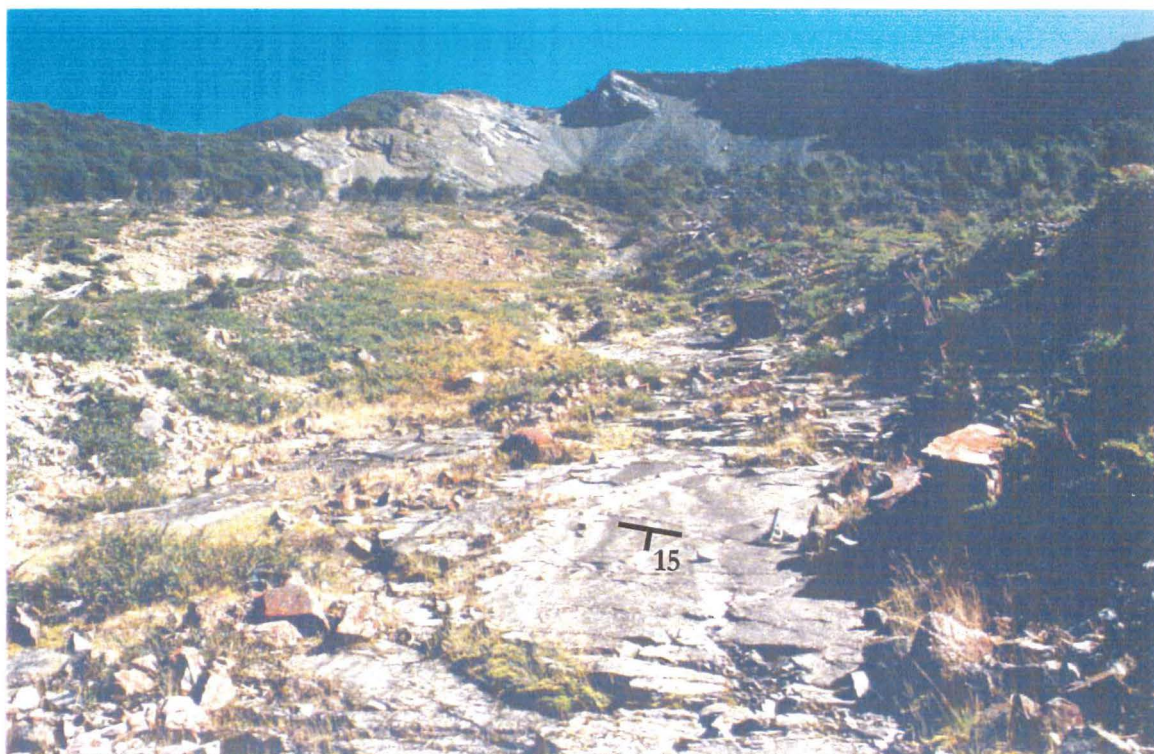
Fig 4.6. Planar joint surface at the base of zone II looking southwest towards the head of the slide (location 4 Map 1). Joint surface is smooth and planar; its lithotype is an intrusive igneous sill. Note the large amount of debris still on the planar surface left of centre photo. Erosion of the debris on the plane at this point is via a series of gullies that drain the landslide. Strike and dip of the failure surface is shown (photo taken February 2003).

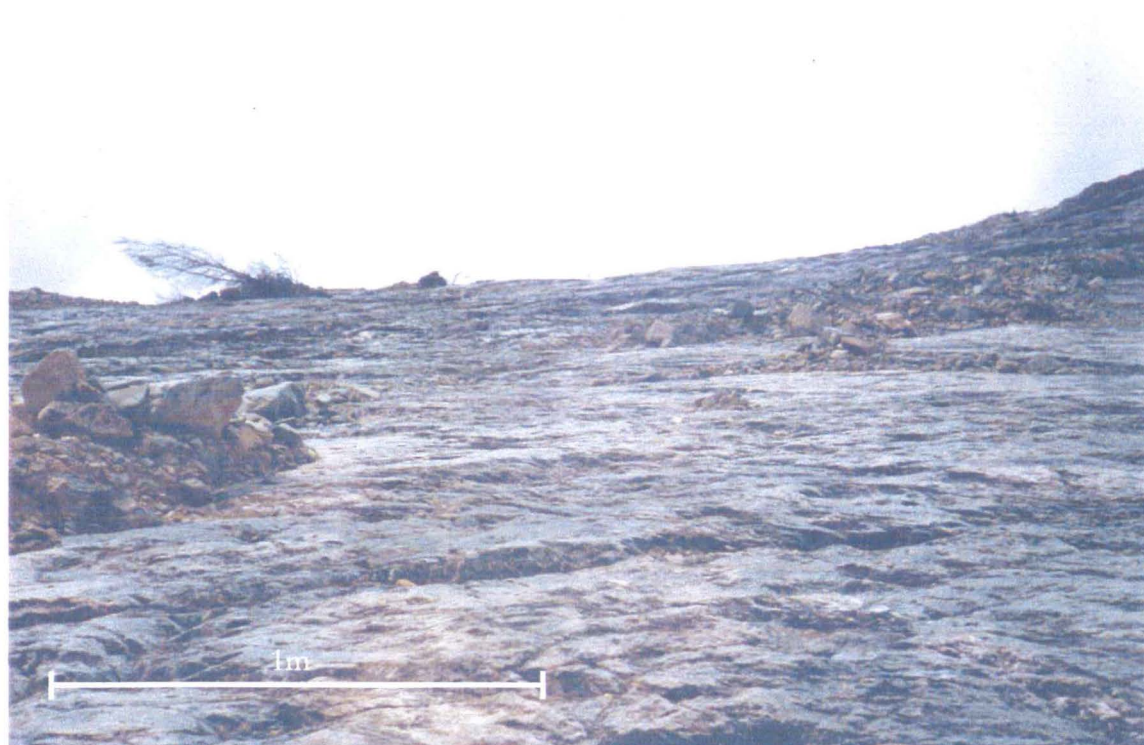
Fig 4.7. Typical planar joint surface in Zone III comprising the intrusive sill as in Zone II . Note the absence of debris due to the steepness (30 degree) dip of the joint surface (location 5 Map 1)(Photo taken 13.3.1997).

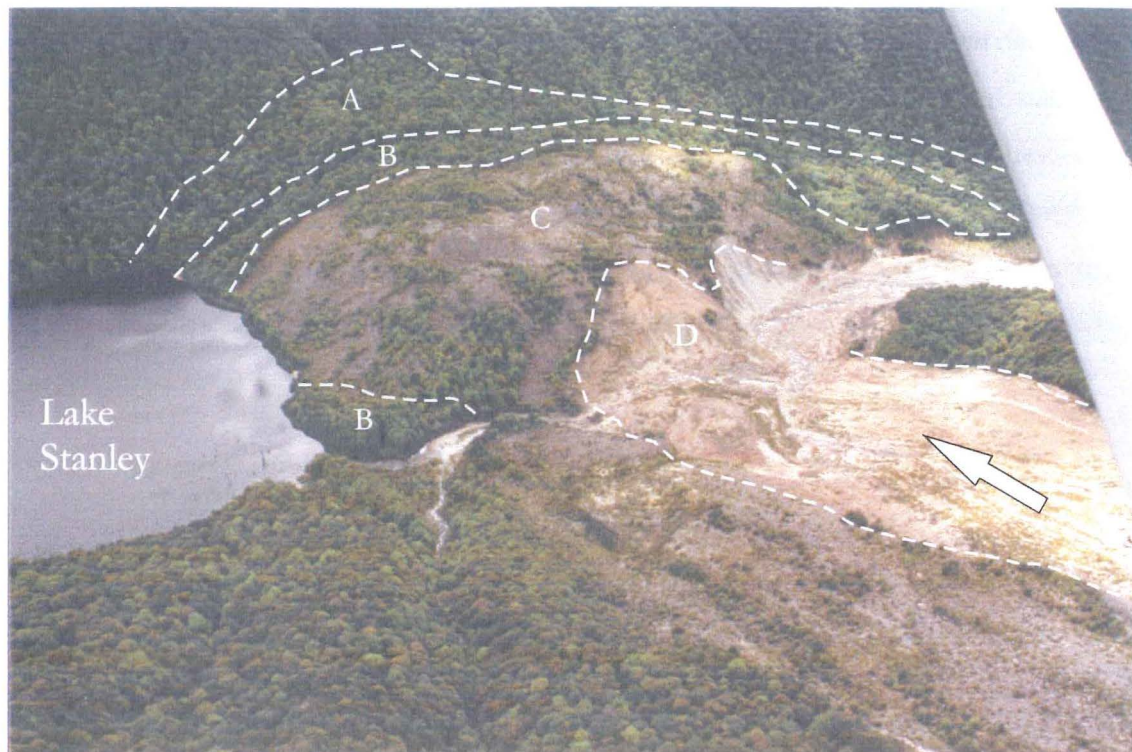
Fig 4.8. View of the dam material looking north illustrating zones within the vegetation that define landslide events. Stand A is the oldest vegetation band associated with landsliding prior to 1929, Stand B correlates with the 1929 landslide, Stand C correlates with a landslide between 1929 and 1968, and Stand D correlates with landsliding in 1994. White arrow represents 1994 landslide movement direction.

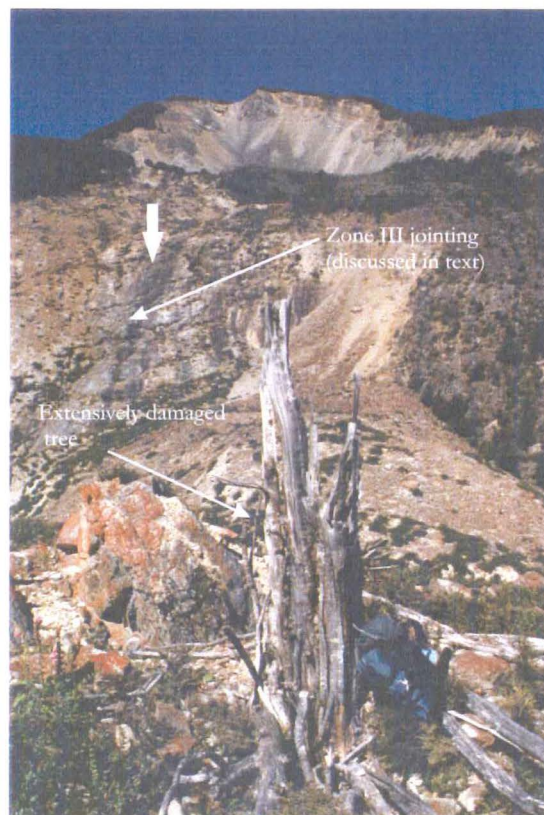
Fig 4.9. View of the landslide complex from the dam material looking south east illustrating the damaged tree resulting from a landslide in 1994 (location 6 Map 1). Arrow represents landslide movement direction. (Photo T. Nash February 2003)

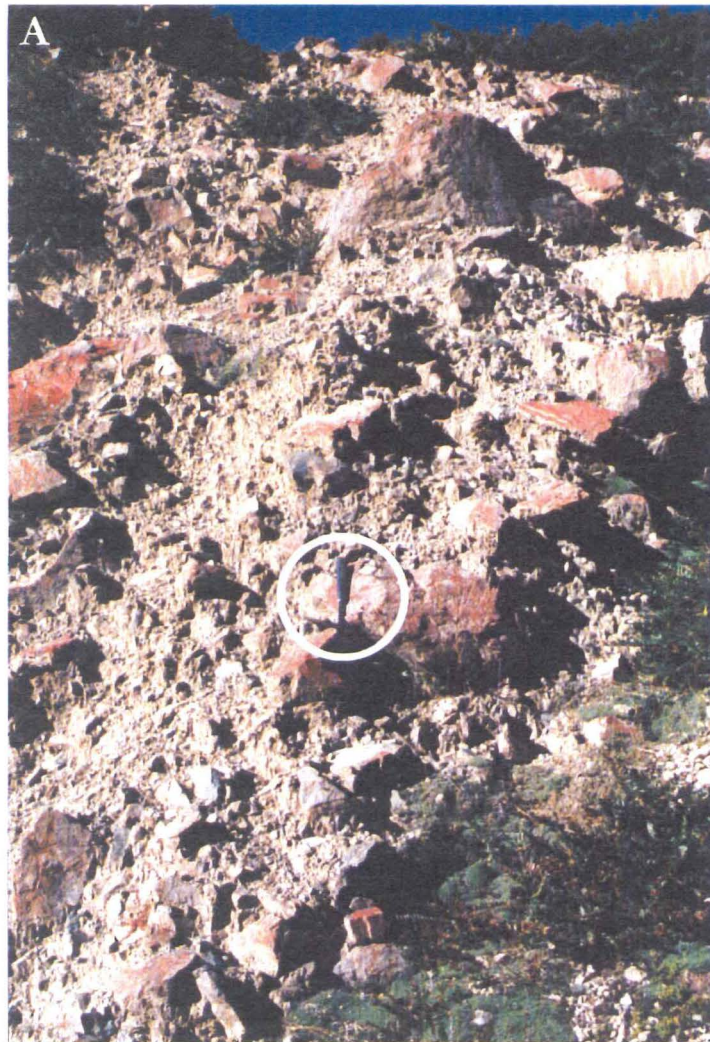
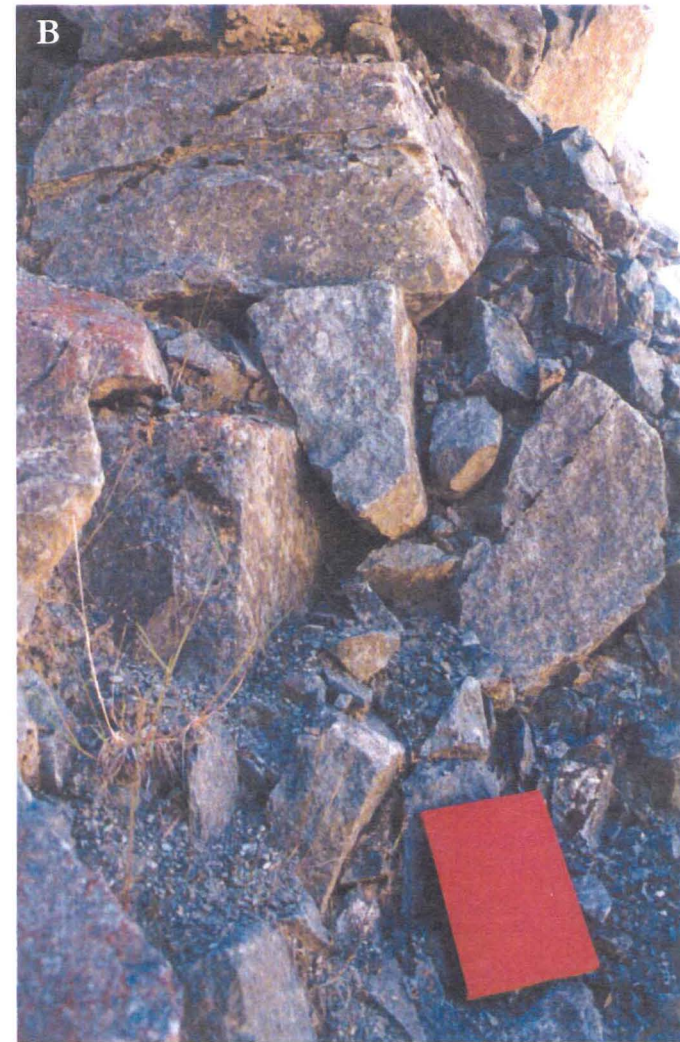
Fig 4.10. A and B. Illustration of the rock material exposed in the spillway walls. This is considered representative of the material comprising Lake Stanley landslide dam. The blocks are in contact with each other and a fine grained matrix is present at an interstitial level. The photographs are taken from a similar area in the spillway wall (location 7, Map 1). Notebook length is 180mm. (Photo taken February, 2003

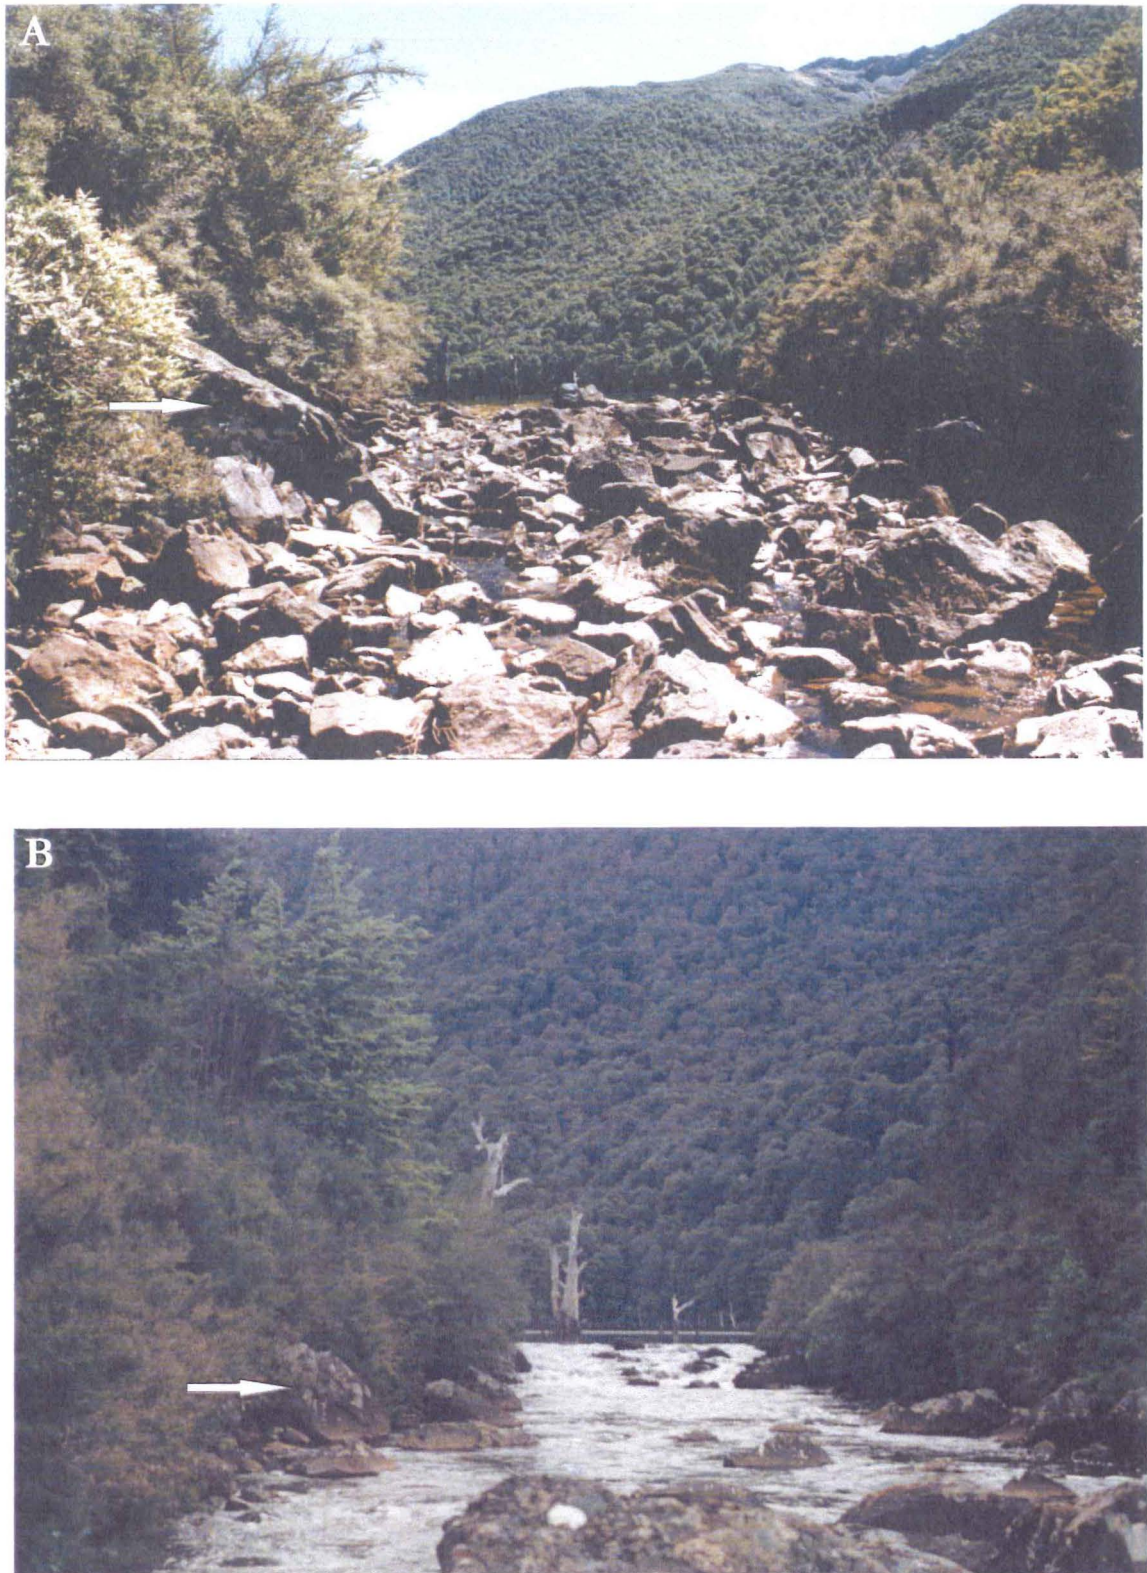
Fig 4.11. **A.** View of the lake outlet looking northwest towards the Lake Stanley (location 8 Map 1). The length of the spillway at point of overtopping is $\sim 10\text{m}$. The height of flood debris above the base of the overflow channel is $\sim 1.5\text{m}$. Note the dead tree stumps protruding from the lake surface (Photo taken February 2003). **B.** View of the spillway during higher flow conditions. The photo is taken from a similar position to A and taken in 1997 (source D. Nottage). The arrow indicates the presence of a block to the side of the main flow that is present in both photos. Some of the blocks within the spillway have moved since the 1997 photo, however generally little has changed.

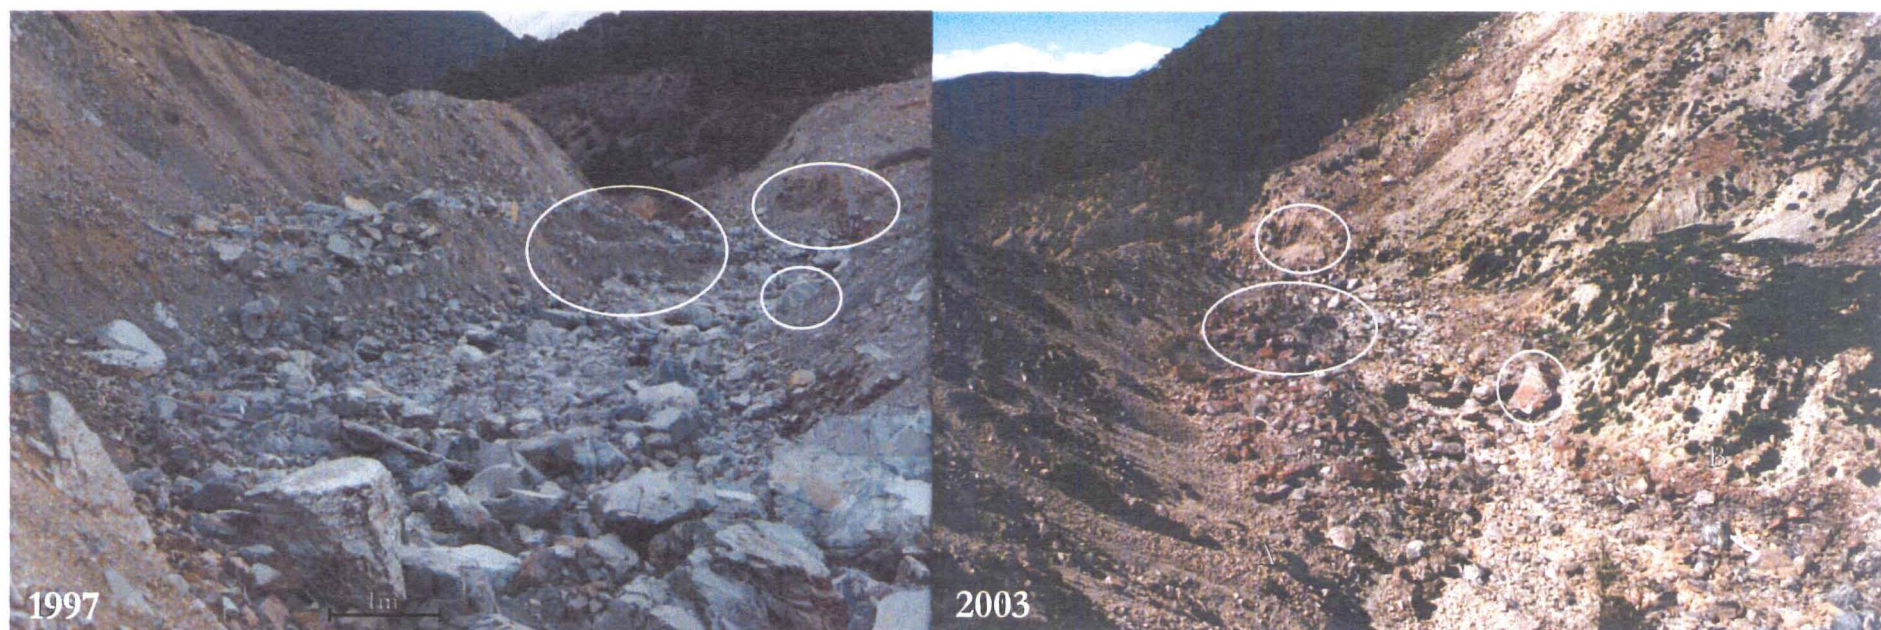
Fig 4.12. View of the spillway Section B looking downstream at location 8 Map 1 for both photos. The left photo was taken in 1997, and the right photo was taken during field reconnaissance for this study in 2003. The circles highlight three features that have been preserved in the spillway since 1997, suggesting limited erosion of Section B. The width of the spillway floor is about 40m.

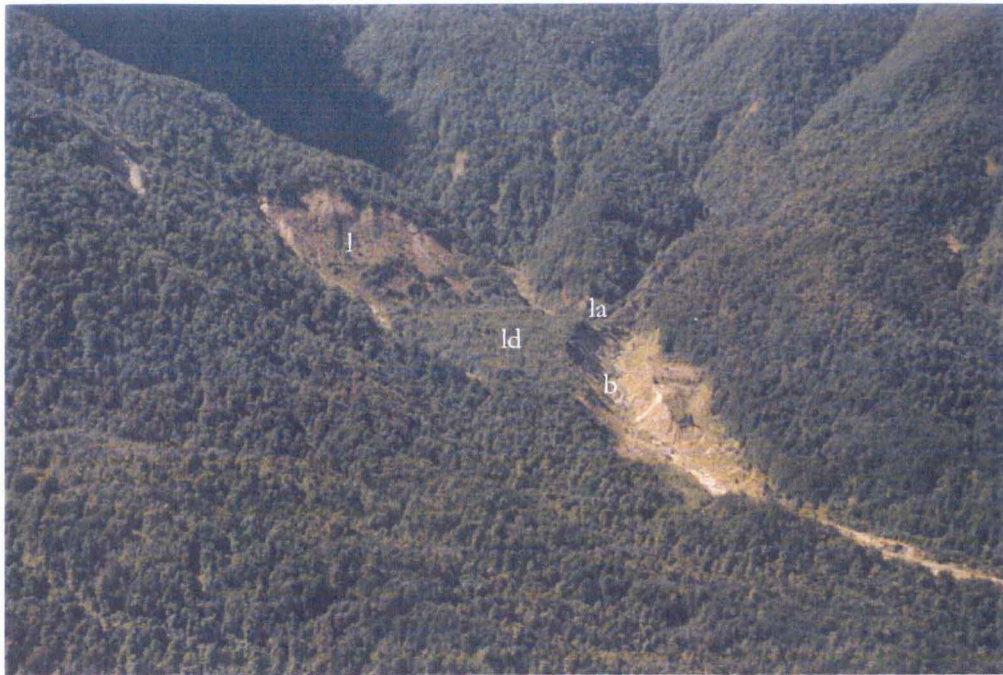
Fig 5.2. Aerial oblique of Ram Creek landslide dam looking east. The landslide (l) was triggered by the 1968 Inangahua earthquake forming a landslide dam (ld) and impounding a lake (la). The landslide overtopped eroding a v-shaped notch into the dam material discussed in the text as the breached section (b). Note the relative lack of vegetation in the breached section of the dam. (Photo taken February, 2003).

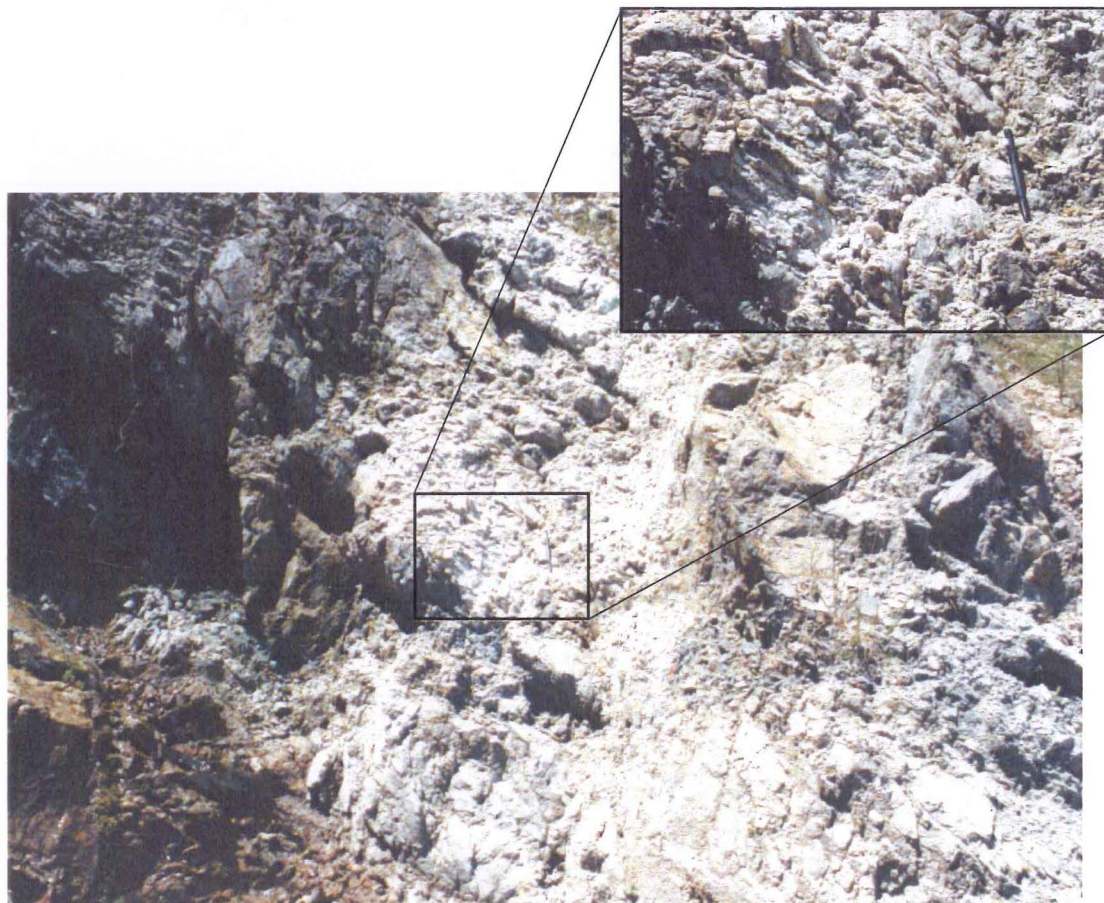
Fig 5.3. Location 1 (Map 2) illustrating the source rock mass characteristics. Note the deep weathering profile of the granite indicated by the intense discoloration within the mass. The highly fractured nature of the mass makes it difficult to obtain representative structural data for kinematic analysis of the landslide. The inset details the rock mass and shows the presence of extensive potash feldspar zones within the granite.

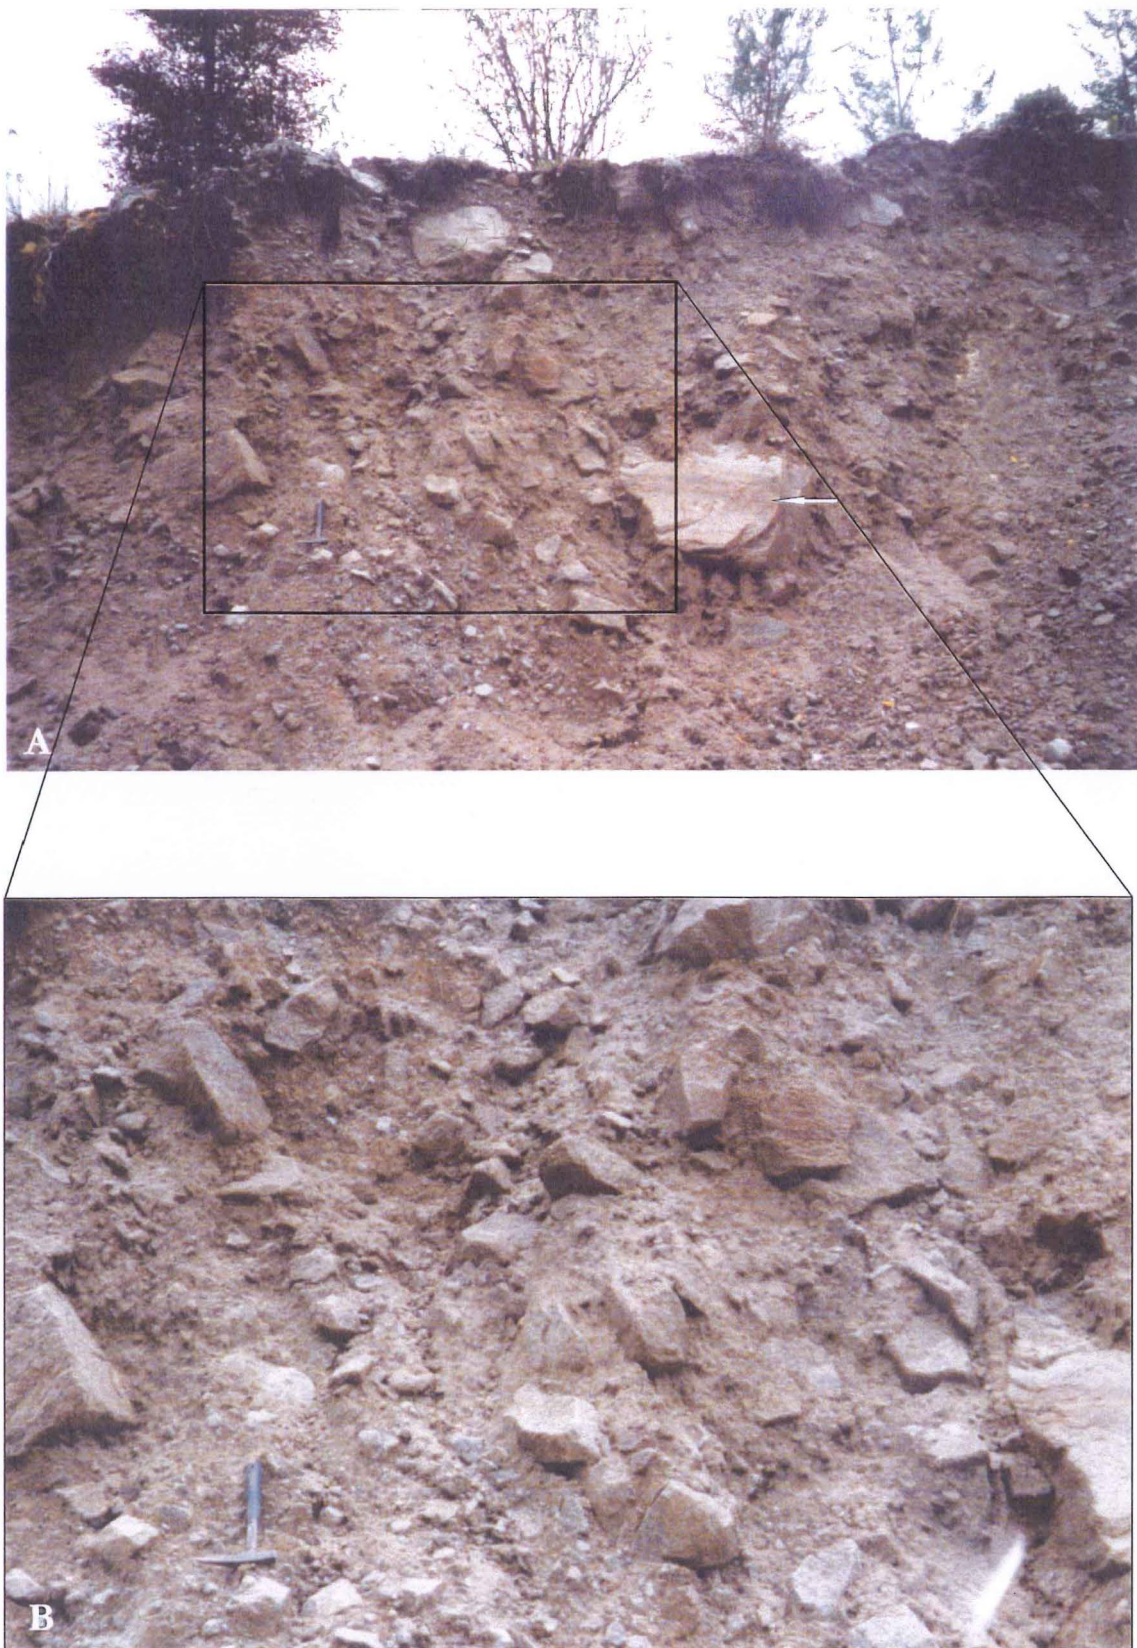
Fig 5.4. Location 2 (Map 2) illustrating the dam material comprising the landslide dam, which is considered representative of the entire dam mass. The arrow (A) shows the largest size clast of 1m in diameter and an estimated D_{50} of 70mm (B). See text for a detailed description of the rock material properties (photo taken April, 2002).

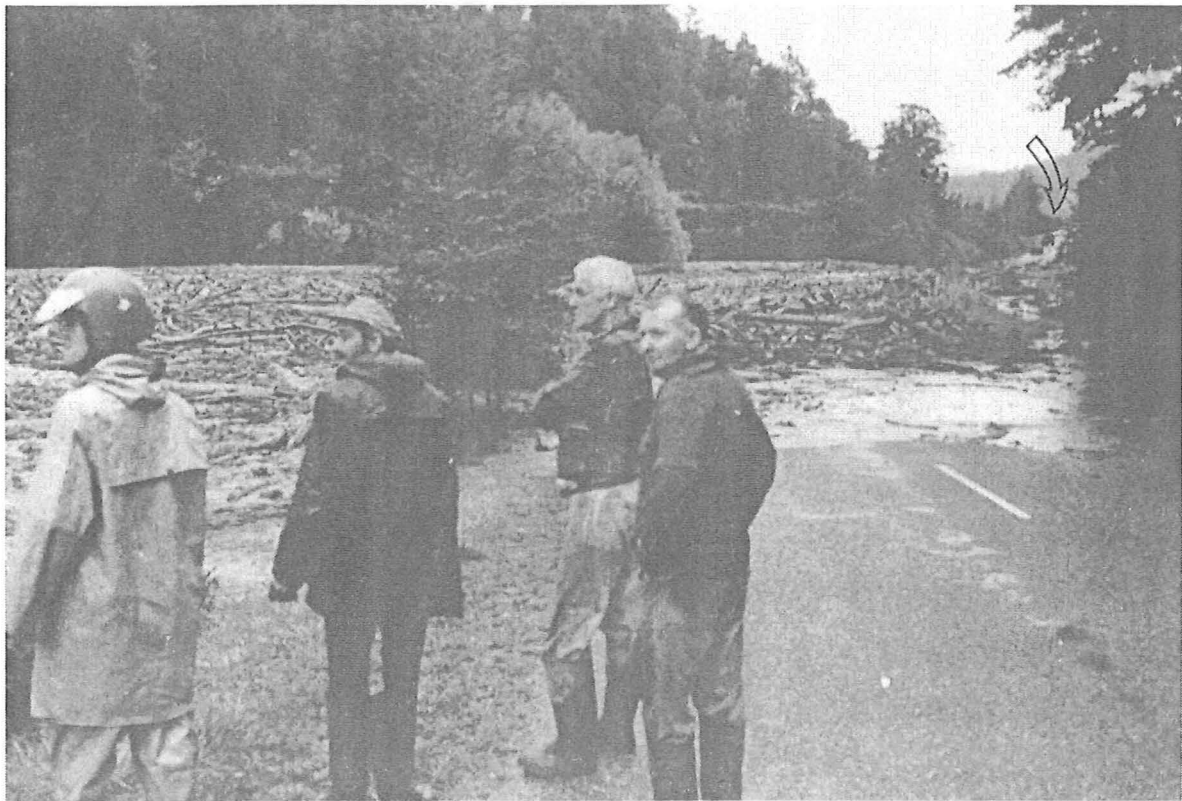
Fig 5.5. Flood debris 5.5km downstream of the dam resulting from the breach of Ram Creek landslide dam on the 29th April 1981 (Location 3, Fig 5.1). The flood wave destroyed the SH6 bridge across Dee Creek (of which Ram Creek is a tributary of) and buried the road under 3 to 4m of logs and debris. Note the trucks in the background (arrow) for scale. (Photo source Inwood, 1997).

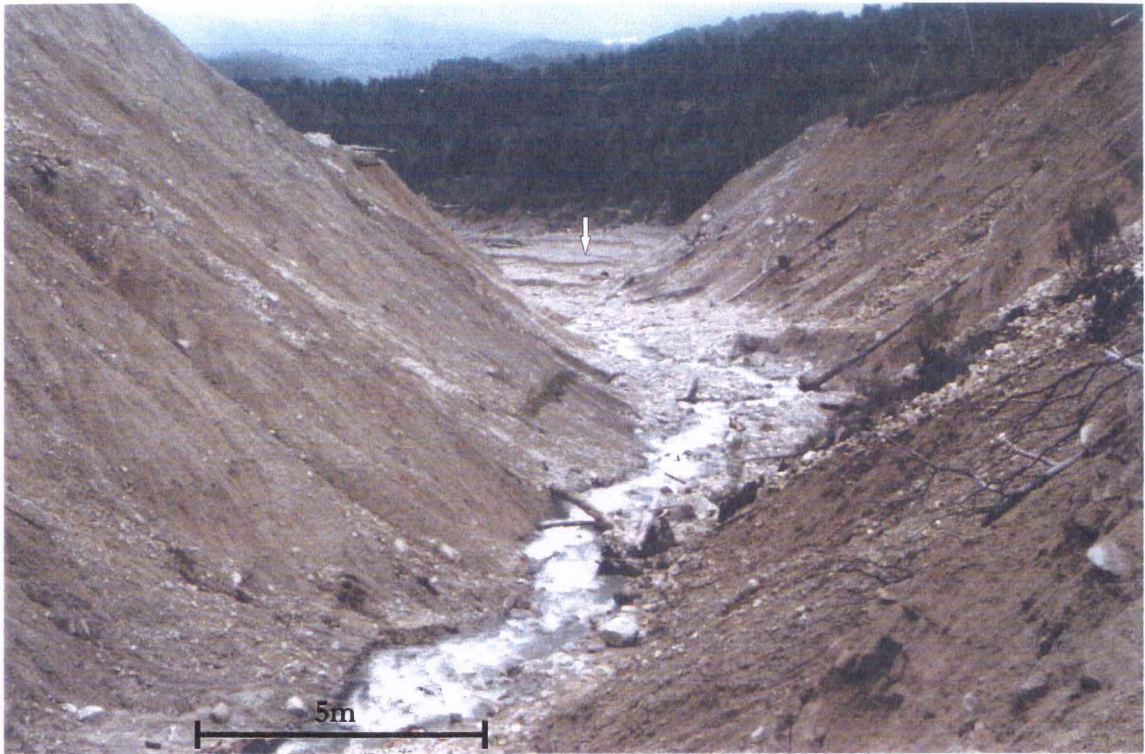
Fig 5.6. Location 3 (Map 2) looking west illustrating the breached section for the landslide dam following failure. Note the absence of large boulders at the base of the breach and the side walls. Outwash terraces are also present downstream of the dam (arrow) (photo source S. Nathan; 21/1/1983)

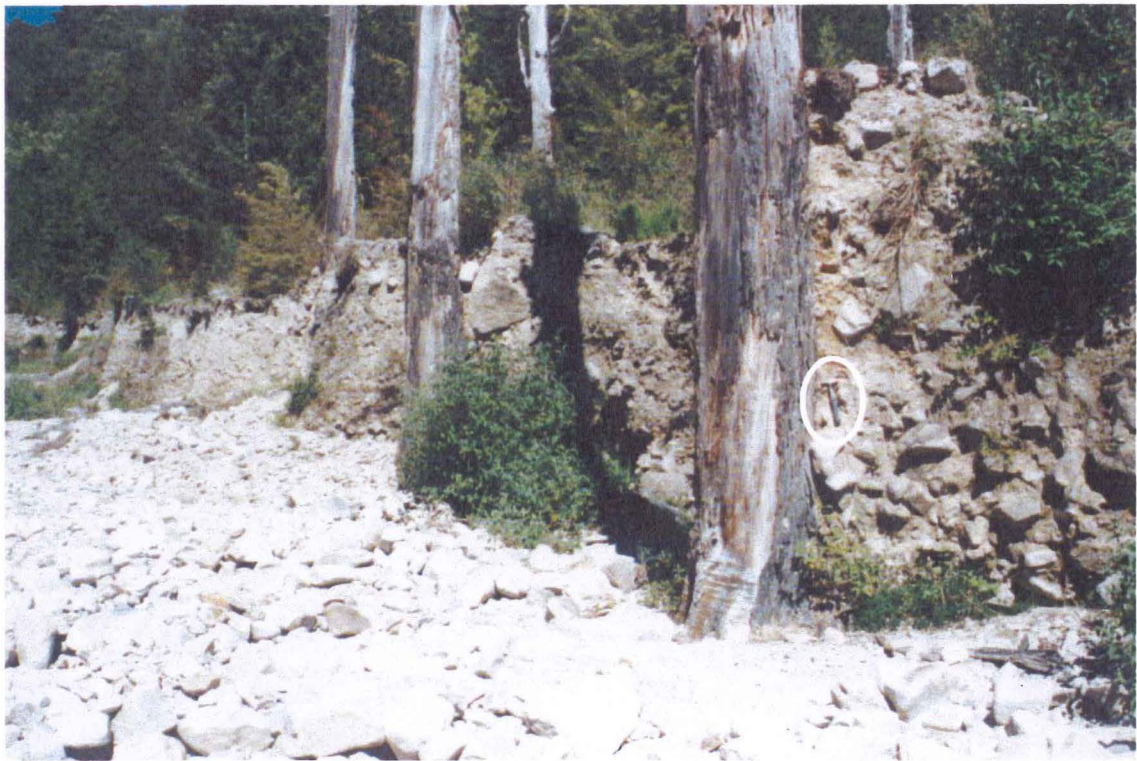
Fig 5.7. Location 5 (Map 2) about 1km downstream of the dam showing > 2m of aggradation from the breaching and failure of the Ram Creek landslide dam. Rock hammer circled for scale. (Photo taken February 2003)

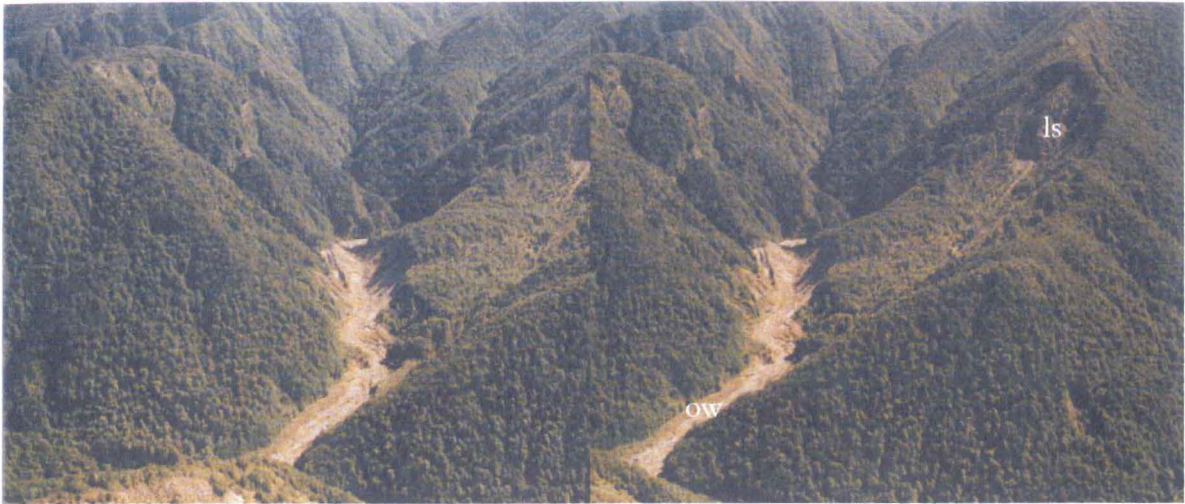
Fig 5.9. Oblique aerial stereo pairs of Rain Peak landslide dam post-failure looking north-northwest. Note the similarities of the v-shaped breached section (centre of photo) of the dam here with Ram Creek breached section (Fig 5.2). The image also shows the landslide source (ls) and outwash deposits (ow) downstream of the dam. (Photos taken February 2003).

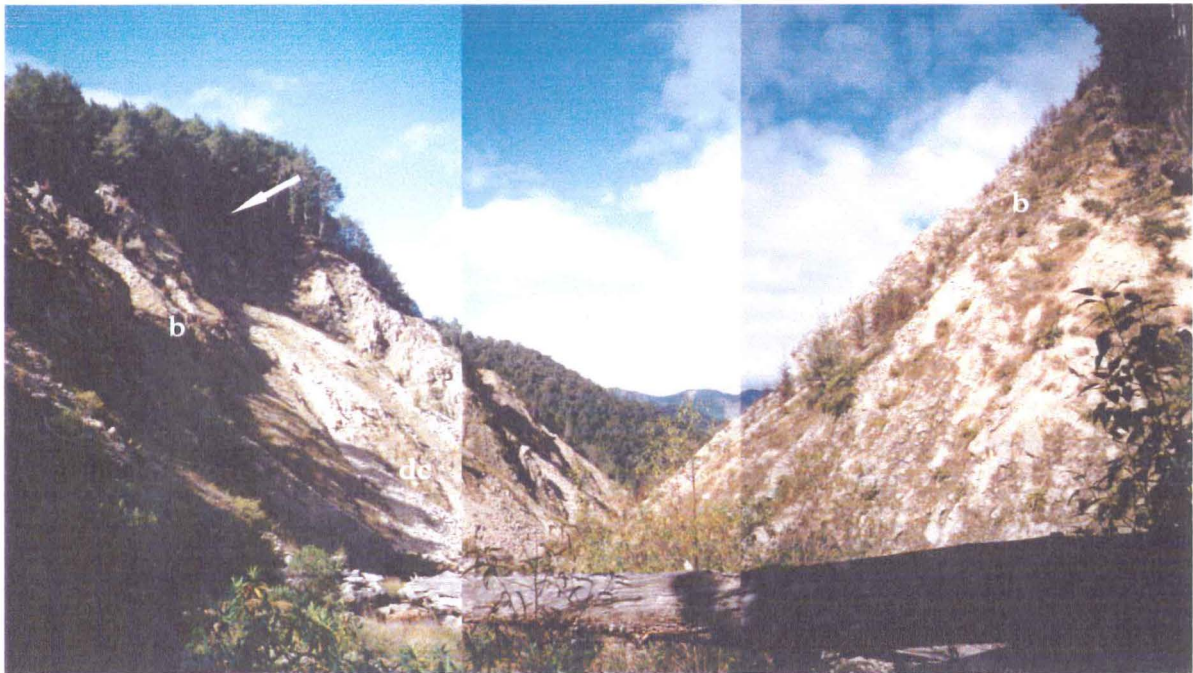
Fig 5.10. View looking southeast in the direction of flow (location 3, Map 3) at the breached section of the dam (b). Landslide direction is from left to right. The top of zone II (arrow) is ~ 45m above the breach floor. Note the debris cones (dc) development at the base of the true left breach wall. (Photo taken April 2002).

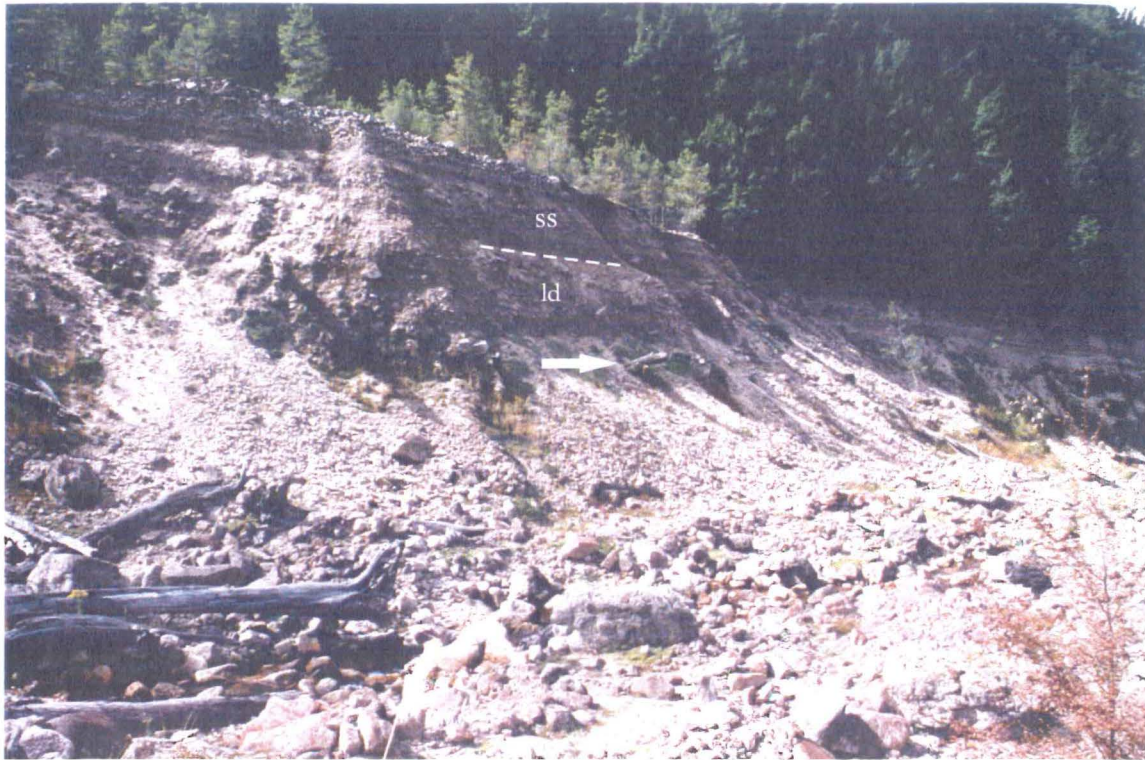
Fig 5.11. Stratified sediments (ss) 700m downstream of the Rain Peak lake (location 4, Map 3) overlying massive landslide deposits (ld) from movement in zone II. Note the logs protruding from the slope (arrow) within the landslide deposit. Active erosion of the terrace is evident with the build up of debris at the base of the slope. Note also the lack of large boulders within the landslide/outwash deposits and the regrowth on the outwash debris. Height of the terrace above the valley floor is ~ 4m. (Photo looking southeast taken February, 2003).

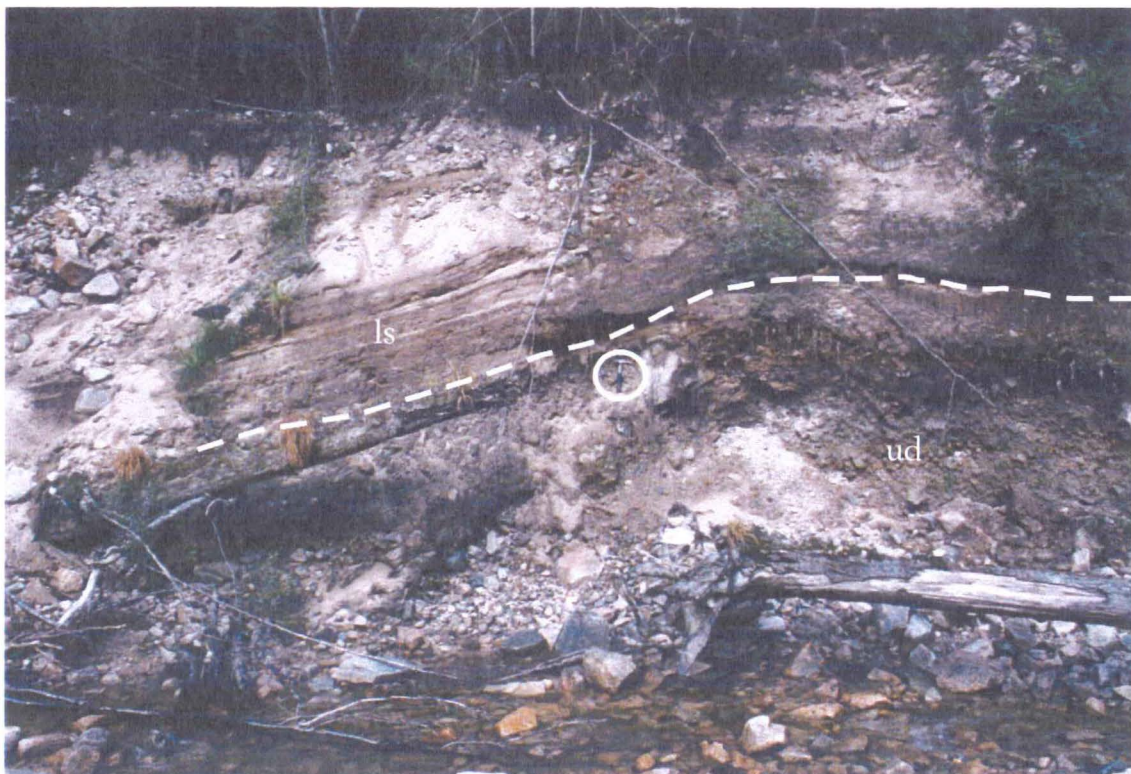
Fig 5.12. Finely laminated lake sediments (ls) at location 5 (Map 3) overlying undifferentiated deposits (ud) inferred to be stream alluvium. Note the large block to the right of the hammer (circled) measuring 400mm in diameter. Large clasts like this are absent within the finely laminated lake sediments (above dashed line) (photo taken February, 2003).

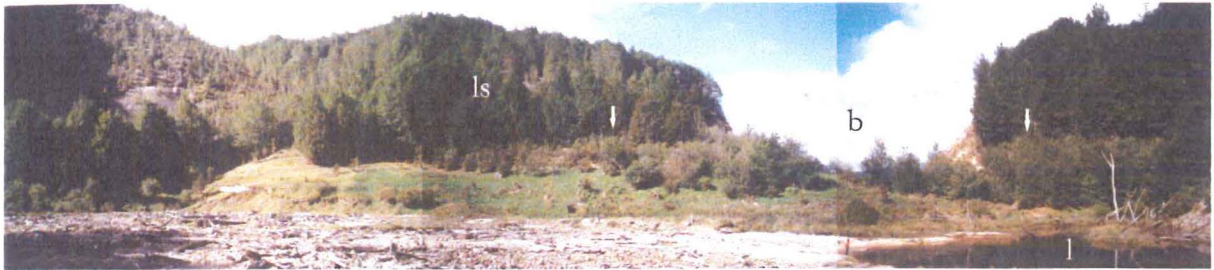
Fig 5.13. Panoramic view illustrating the present lake (l), breached section of the dam (b), landslide deposits (ls) and original lake level (vertical arrows). Photo position location 7 (Map 3) looking southeast. Horizontal arrow locates fine-medium grained stratified lake sediments. Note person at edge of lake for scale.
